International Course on River and Wetland Restoration

Restoration projects

Restoration
projects
funded by
The Operational
Programme
Environment

Restoration of the Jordán river arm, Týniště nad Orlicí

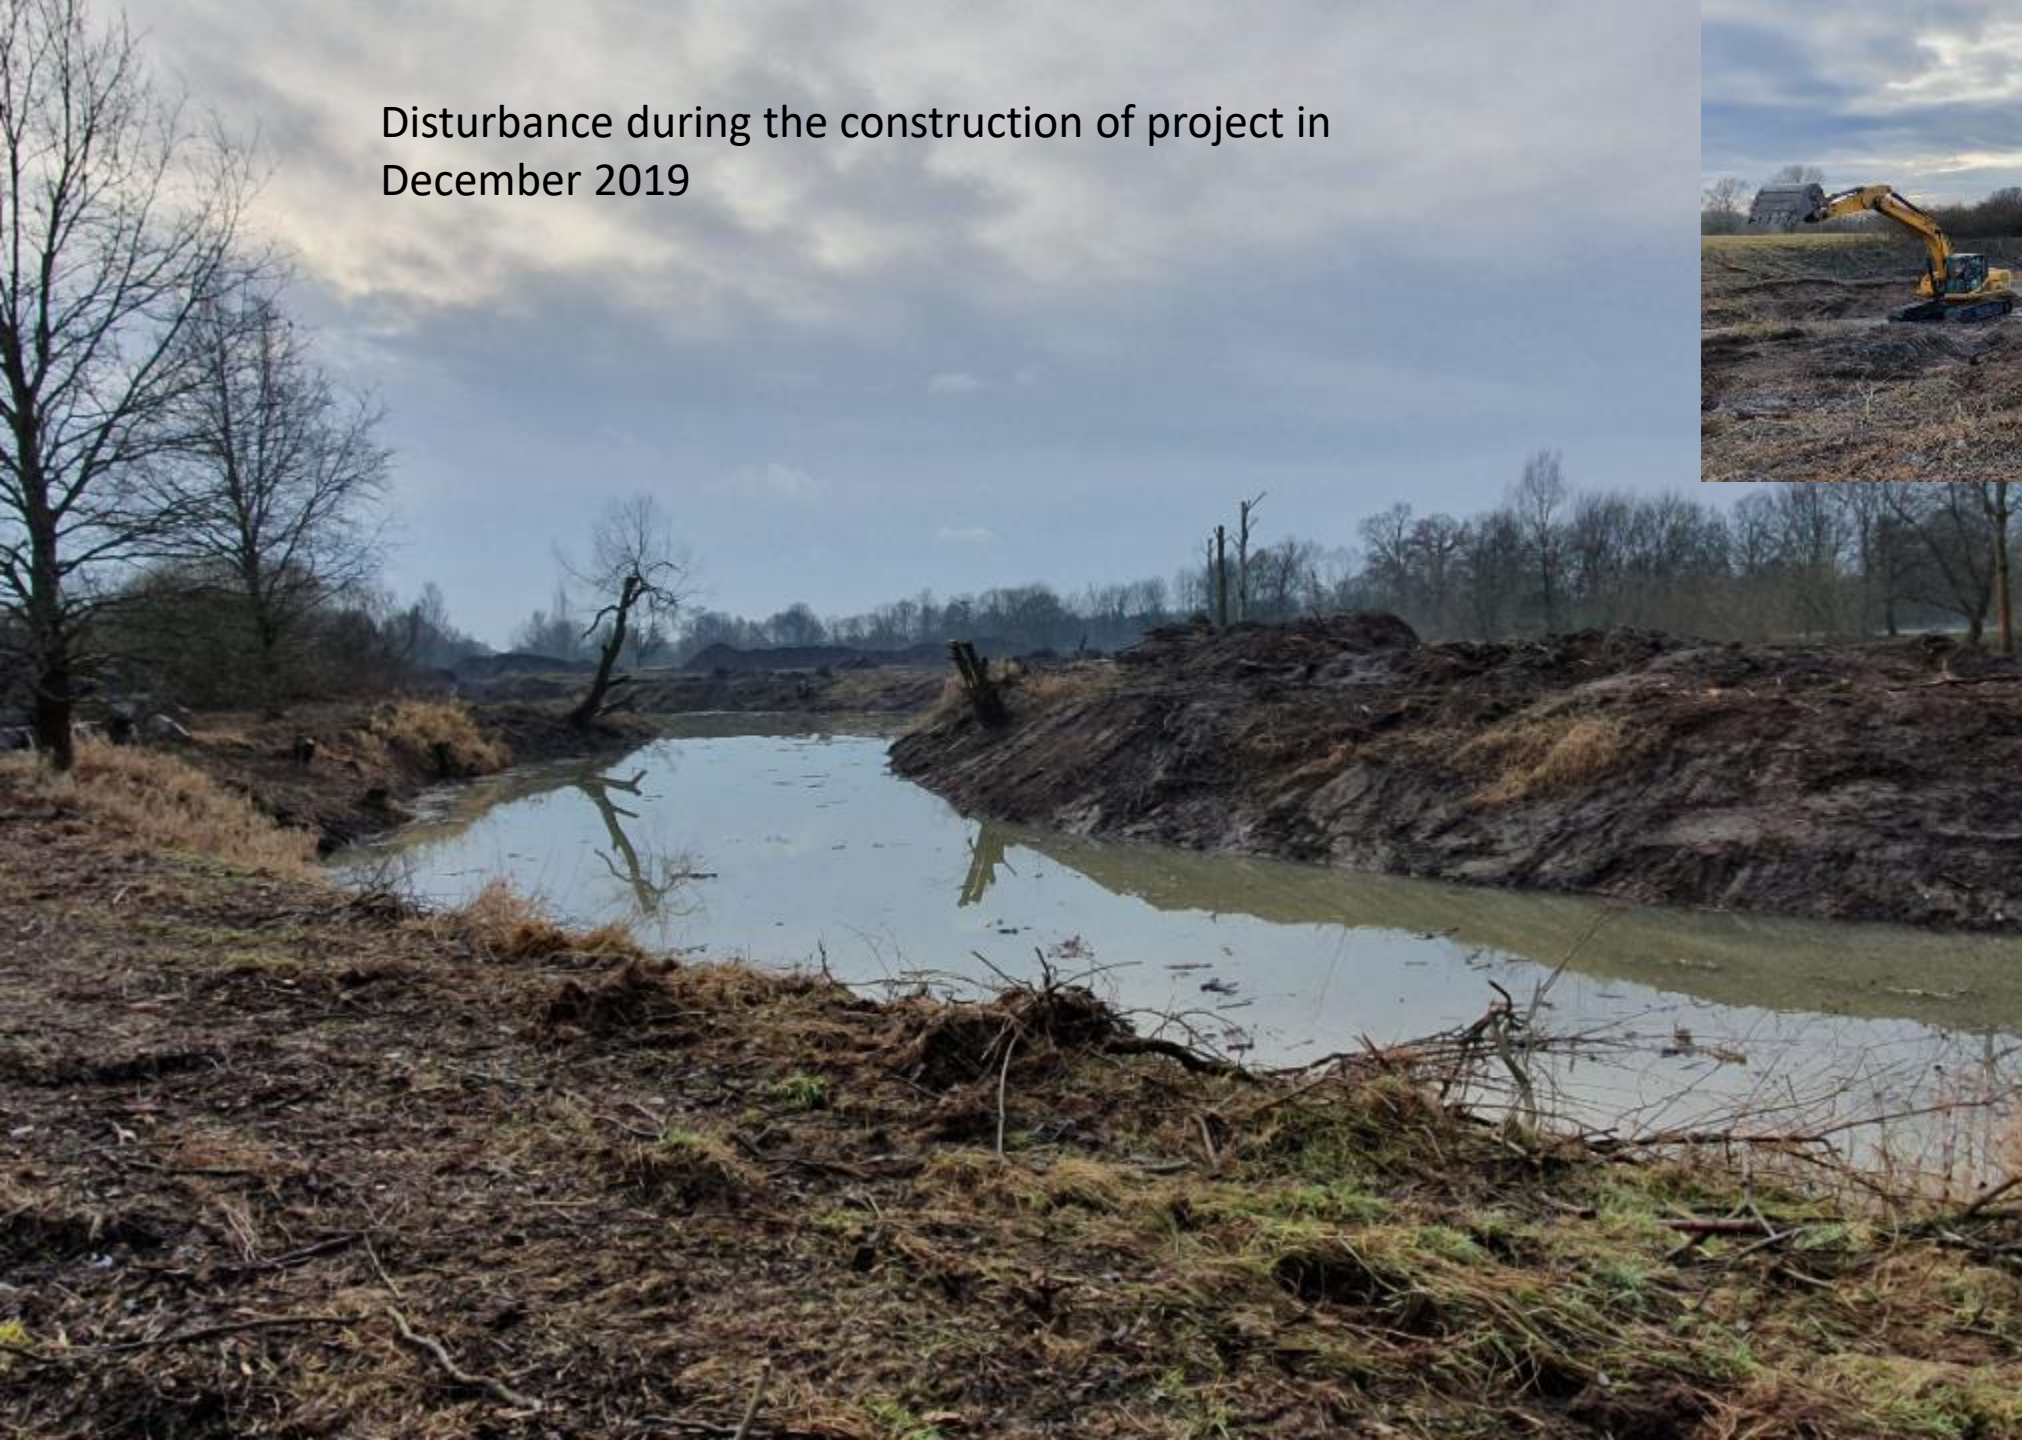
modeling of the Orlice River channel respecting the original morphology

works were affected by floods, February 2020

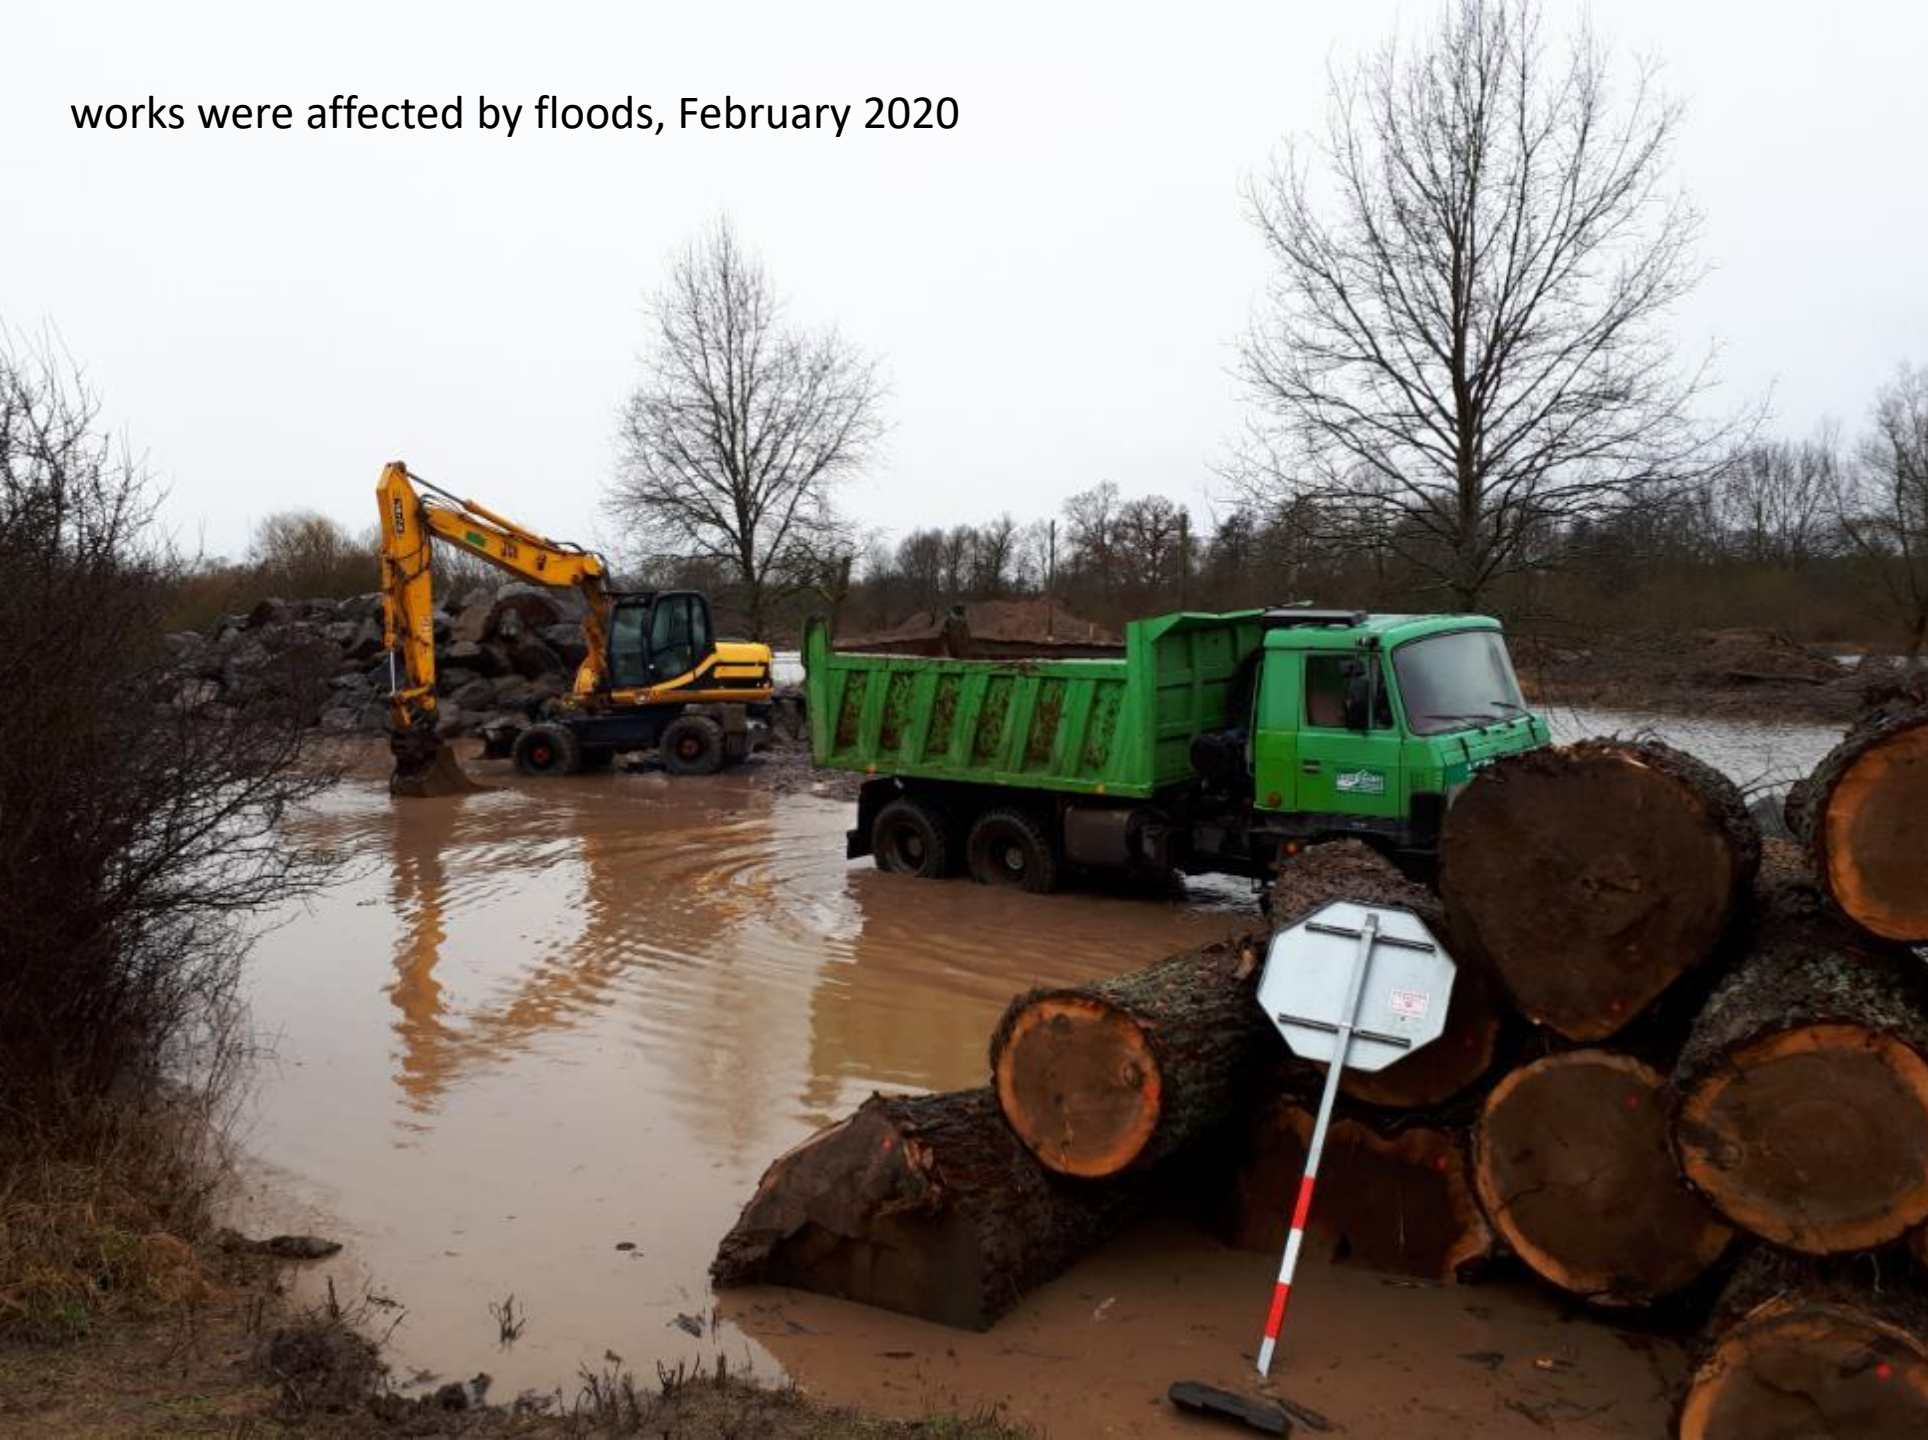
restored Orlice channel in April 2020

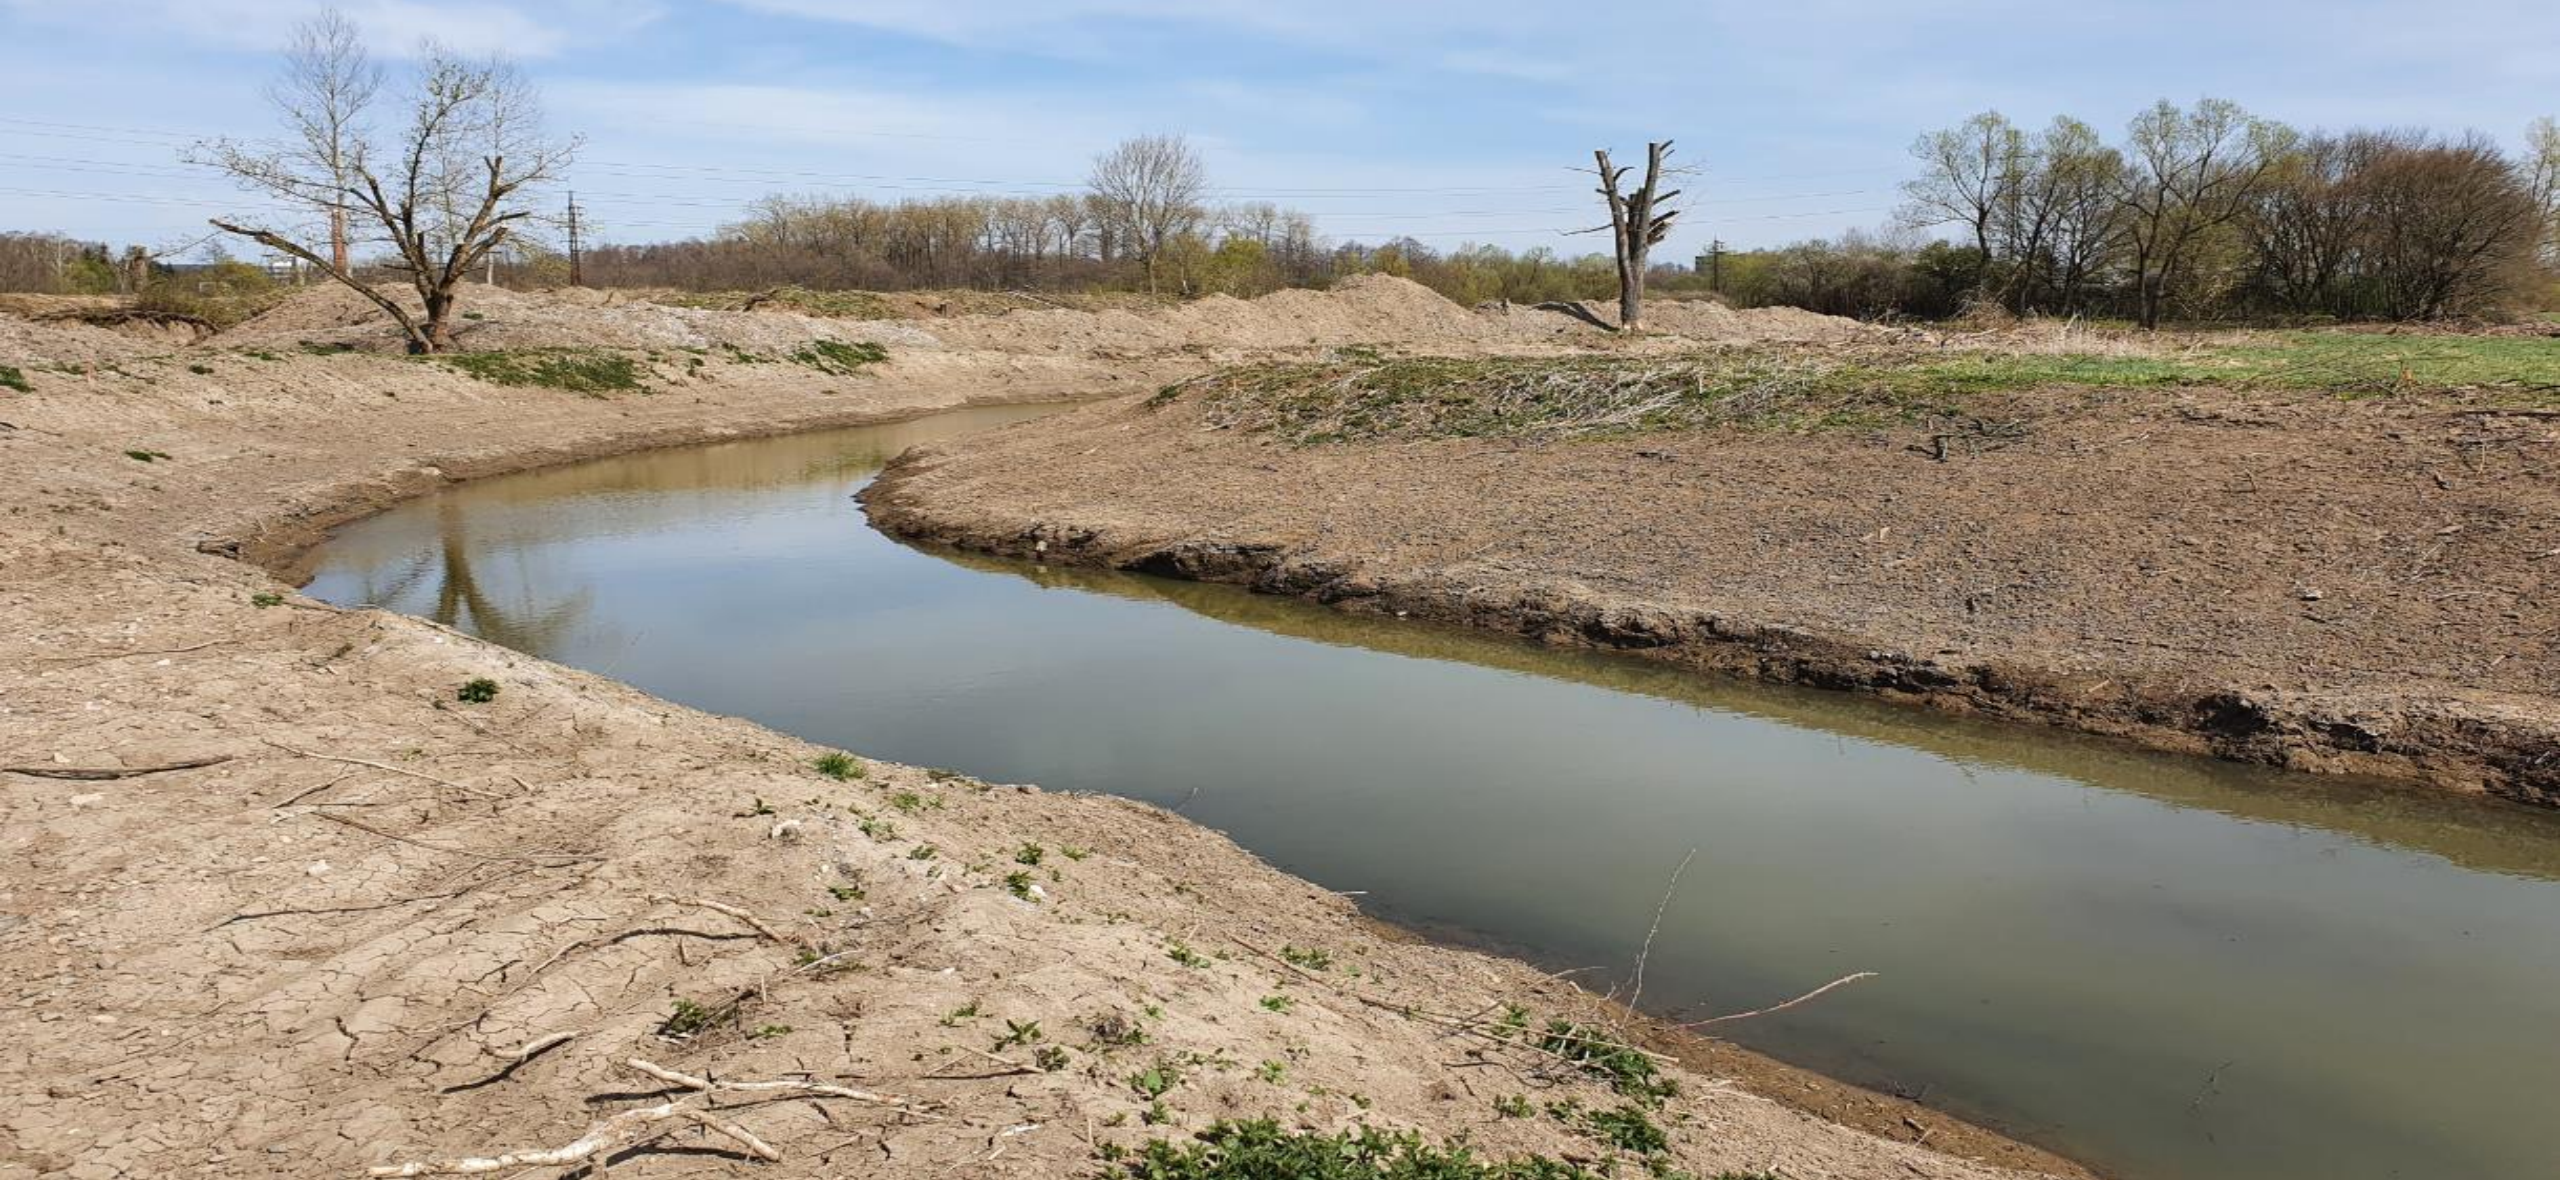
new habitat pools

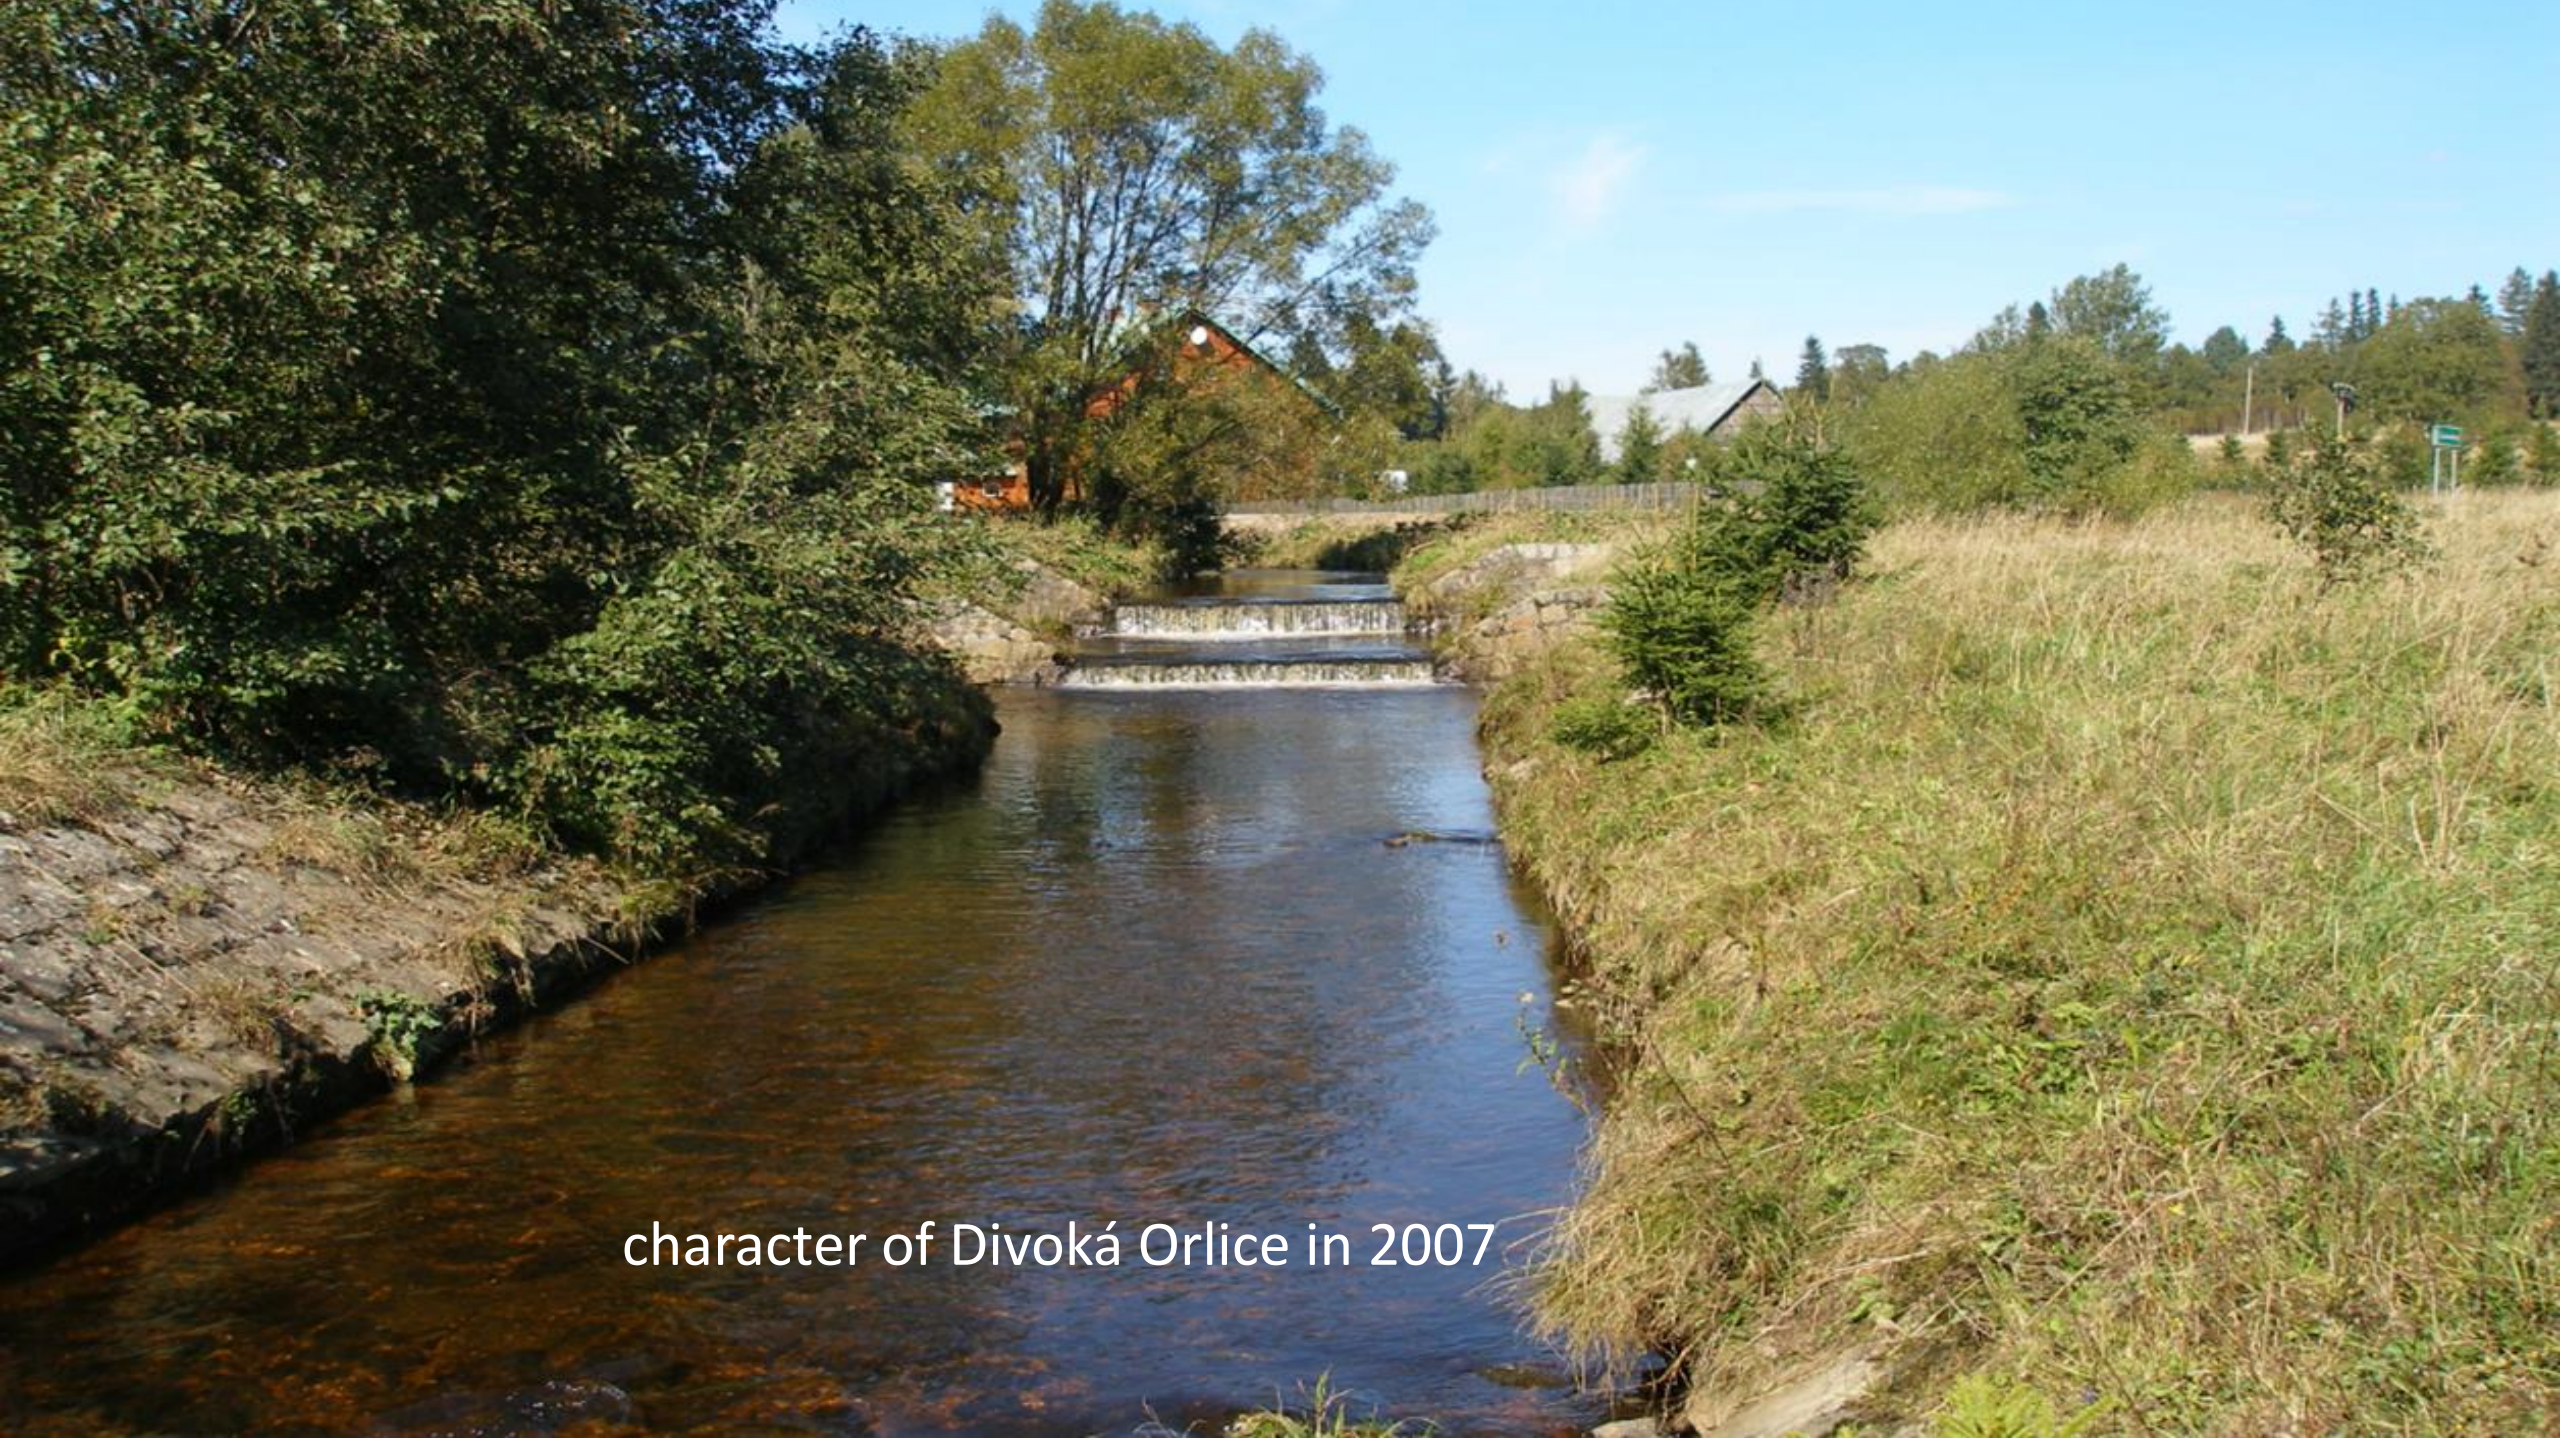
character of Divoká Orlice in 2007

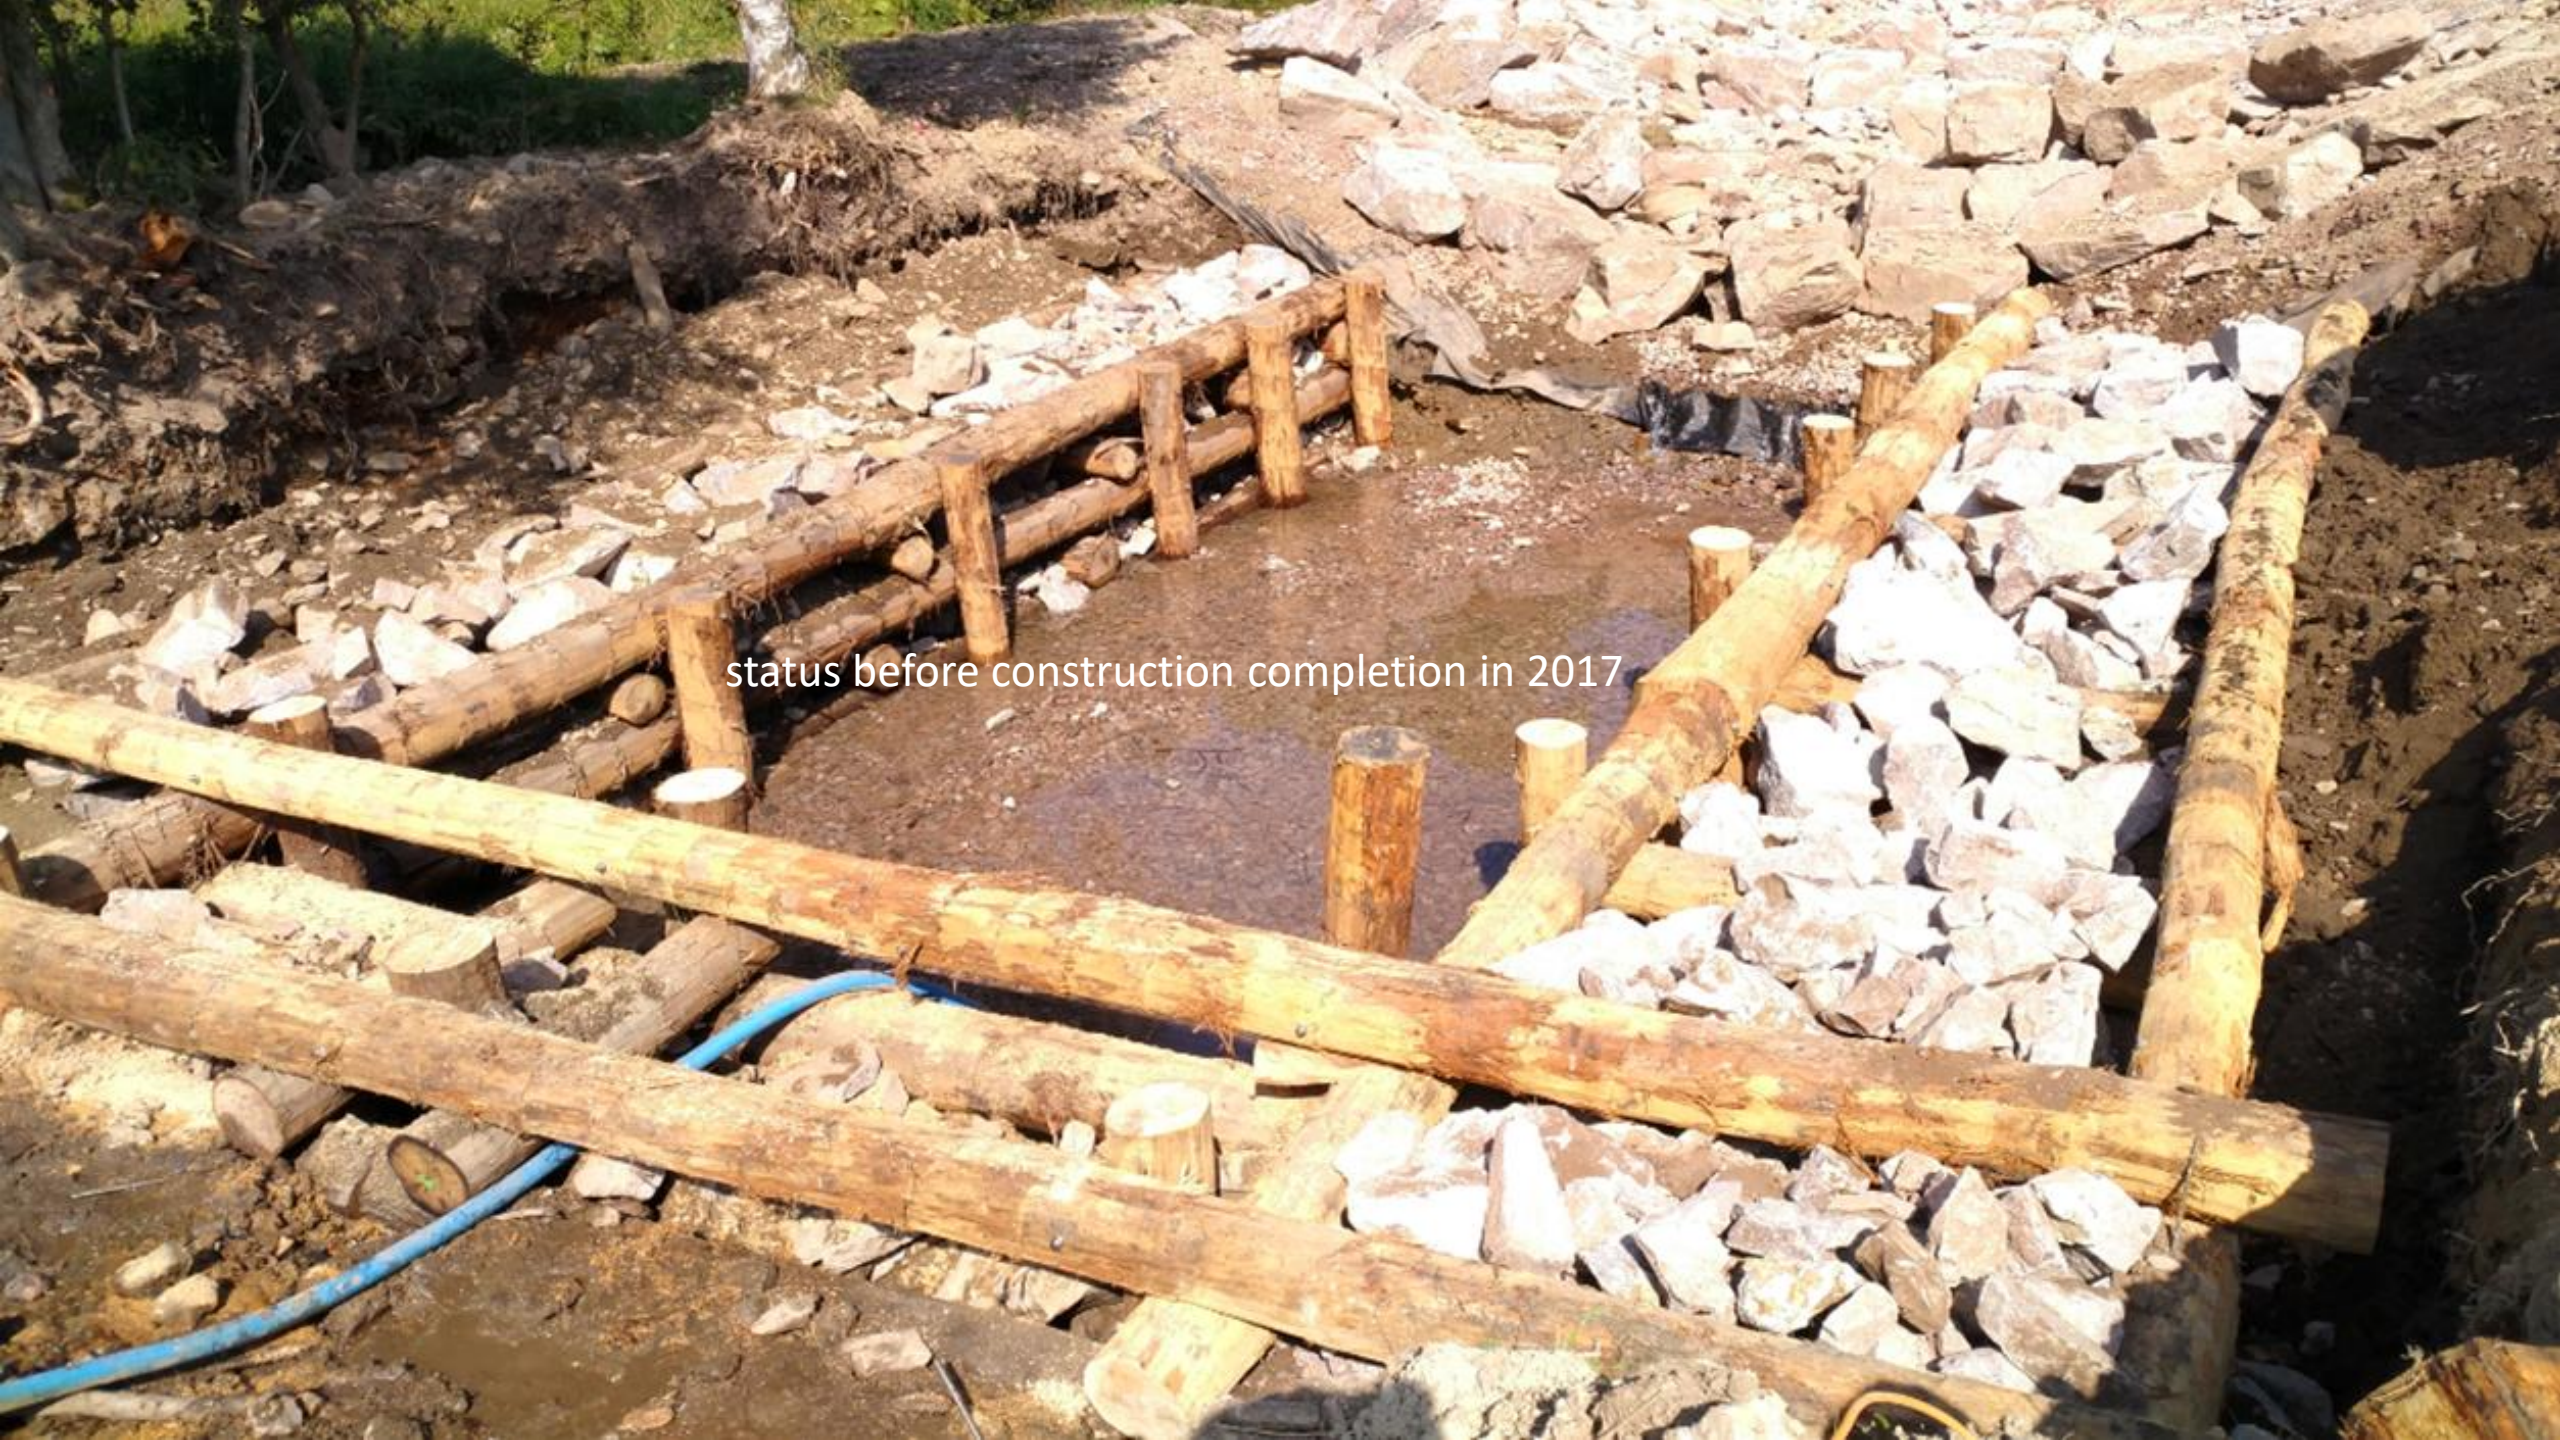
status before construction completion in 2017

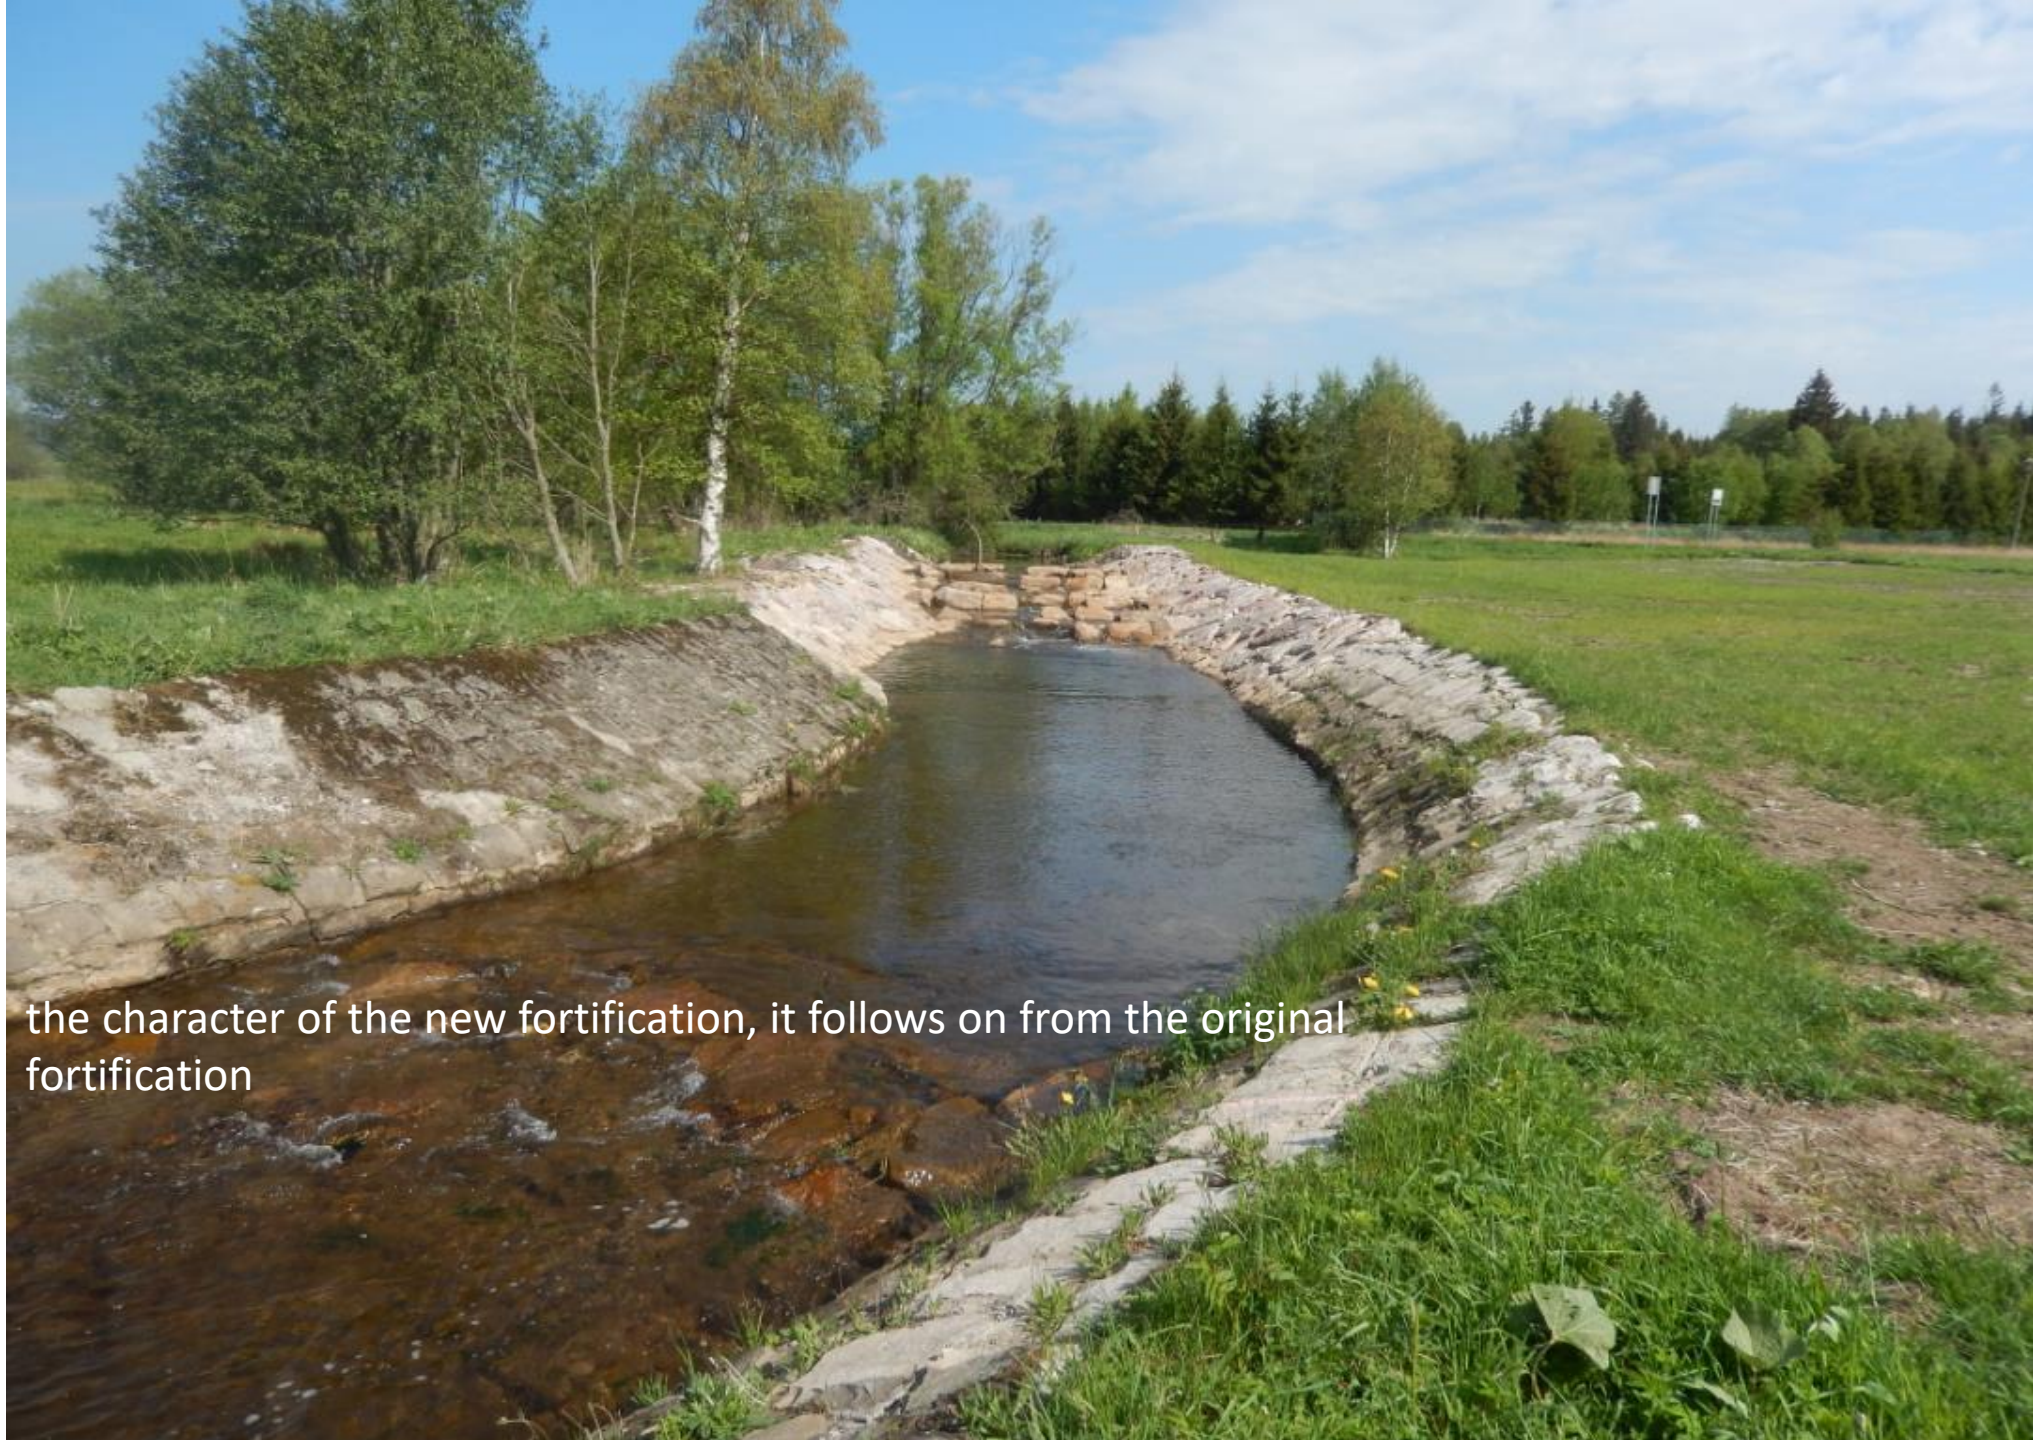
the character of the new fortification, it follows on from the original fortification

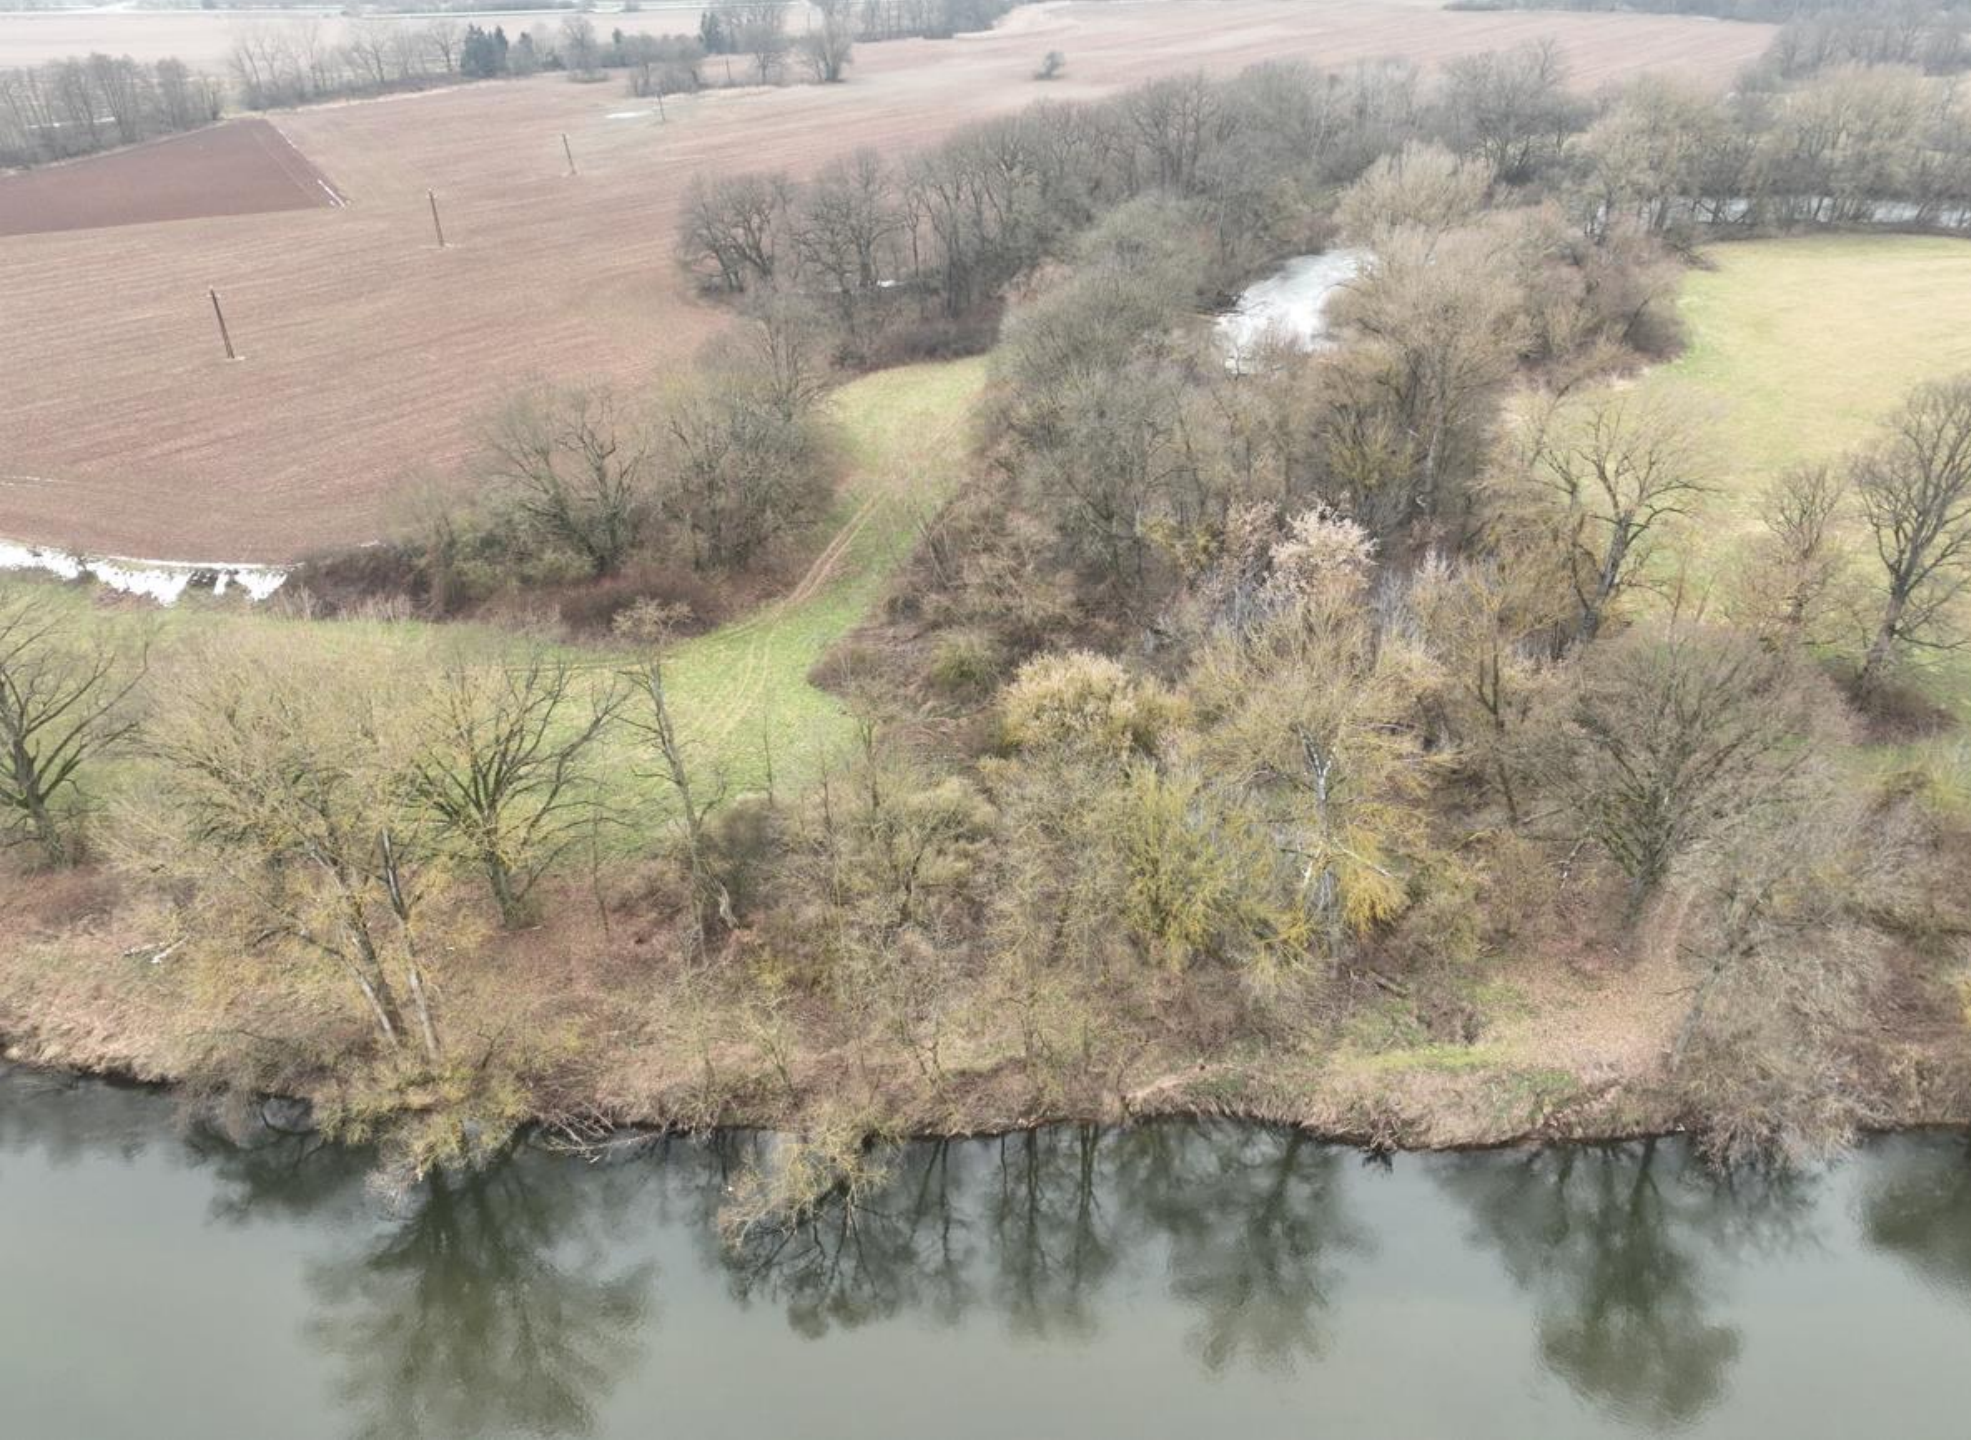
**Tůň u Hrobic before
restoration
January 2025 – place
for restoring
connection to the
Elbe River
(photo: Jakub
Medek)**

- in accordance with the care plan for the Nature Monument Tůň u Hrobic
- modification of the connection of the river branch by constructing a ford made of stone flats
- restoration of habitats for rare macrophytes (e.g. European frobit), zones with no intervention
- black poplars (*Populus nigra*) and their habitat-dependent beetles were preserved, management of riparian stands, non-native trees were cut-down
- during construction works – pool for rescue transfers
- implementation of restoration measures: **2024-2026**

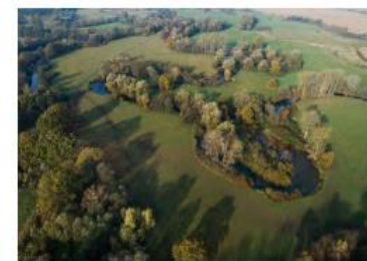
Slepé rameno na podzim 2019

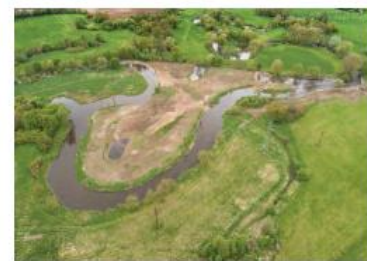
Zpřístupněné rameno v květnu 2021
